Manhole Inspection Summary

Manhole # S49M__026MH

Insp Date: **4/16/08 1:24 PM**

Location Address: **819 s luzerne**

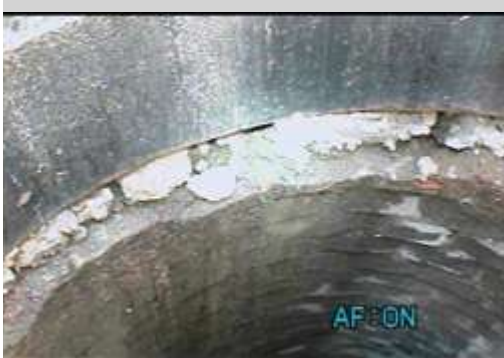
Defect 2

Condition: ☐ Sound ☐ Cracked ☐ Root Intrusion ☒ **Loose Brick** ☒ **Deteriorated**

chimney cond deteriorated, loose bricks

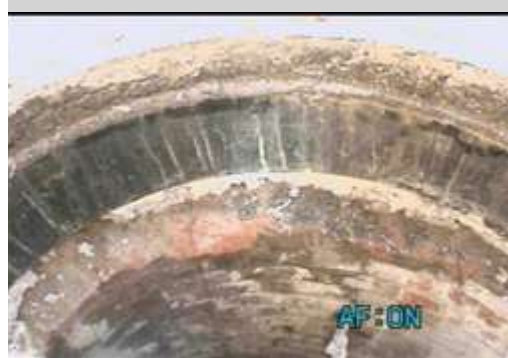
Defect 1

Frame Offset: **2.5** (in.) Condition: ☒ Sound ☐ Cracked ☐ Leaks

off set frame

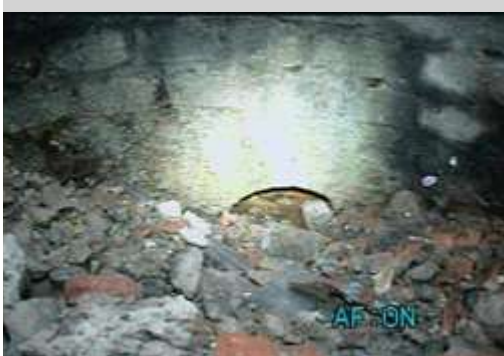
Defect 4

Condition: ☐ Sound ☐ Cracked ☐ Root Intrusion ☐ Deteriorated ☐ Leaks ☒ **Debris**

channel debris

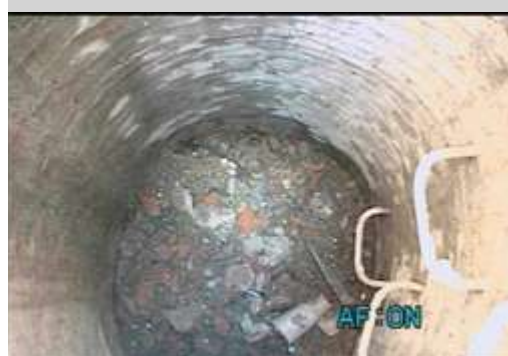
Defect 3

Steps Count: **4** Missing: **0** ☒ **Corroded**

corroded stairs

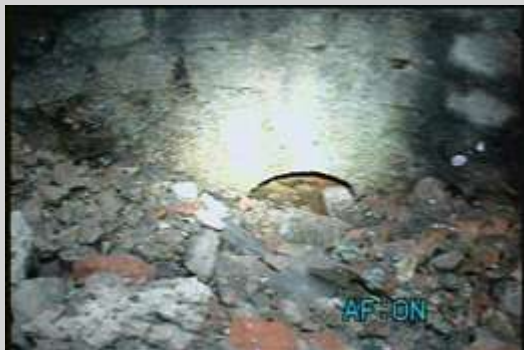
12 O'Clock Outflow

Deposits: ☐ None ☐ Mud ☐ Sludge ☒ **Debris** ☐ Grease

Silt Depth: **7** (in.) Deposits Extent: **Heavy**
